DESIGN DIVISION TECHNICAL REPORT

PHILADELPHIA NAVAL SHIPYARD
PHILADELPHIA, PENNSYLVANIA

COLLECTION OF LETTER REPORTS
OF VIBRATION SURVEYS
ISSUED DURING 1962

F. A. HEINZE
AND
D. S. BROGDEN

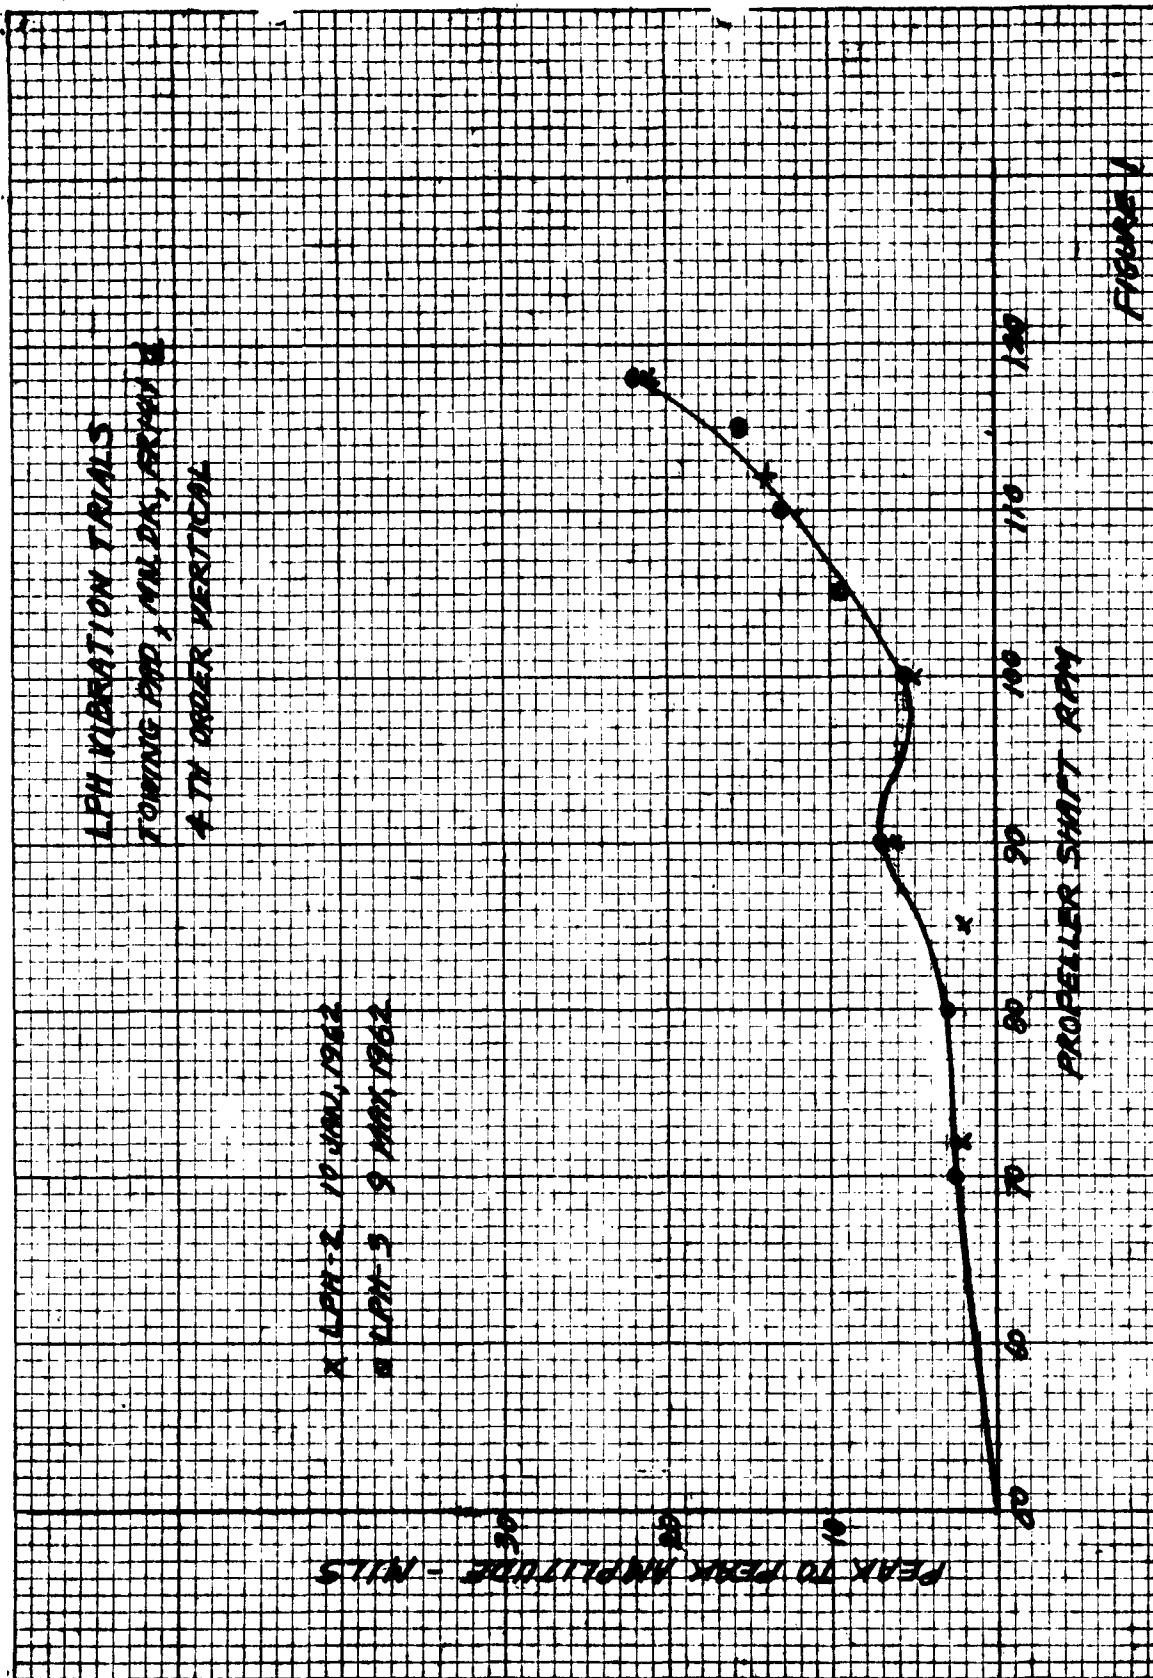
LPH VIBRATION TRIALS
TOWING PAD, HANDED, FROM 1/2
4TH ORDER TRANSVERSE

4. Results of the measurements at the towing pad, Frame 141, are plotted in figures 1 and 2 of enclosure (1). Data obtained on USS IWO JIMA (LPH-2) at 15,900 tons displacement on 10 January 1962 are plotted for comparison. It should be pointed out that vibration levels during hard turns are far from steady and the maximum amplitudes were found to vary considerably between various turns at the same rudder angle and speed. Therefore, the comparison between LPH-2 and LPH-3 in hard turns should not be given too much weight.
